The San Diego Blackout 8 September 2011

The same neglects as in previous blackouts

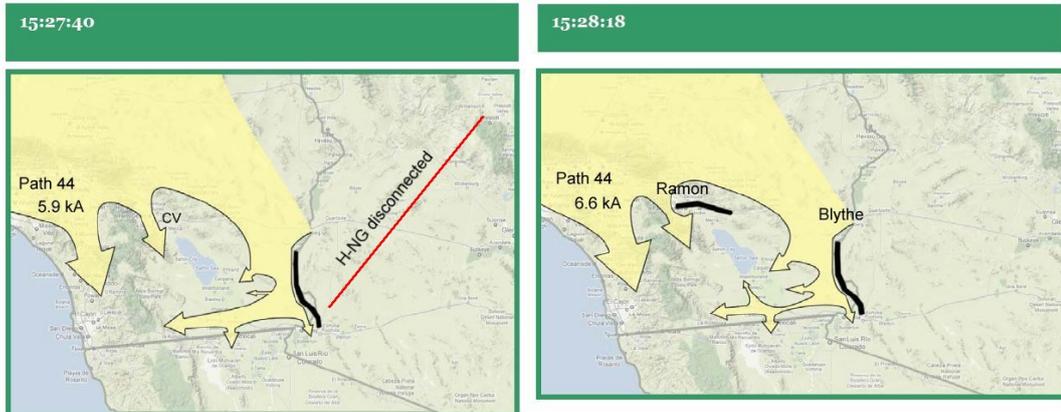
Gila in Arizona. The switching was carefully planned. The technician had completed step 6, but was distracted by other communication and wrote the time on the line for step 8 in his check list. Therefore he skipped two steps and continued with step 9. The result was an arc over the switch and the automatic disconnection of the 500 kV line Hassayampa-North Gila (H-NG).

After the disconnection of H-NG the flows were redistributed. Flow on path 44 increased by 84% to 2,362 MW or 5.9 kA. At 8.0 kA the SONGS² separation scheme would be initiated.

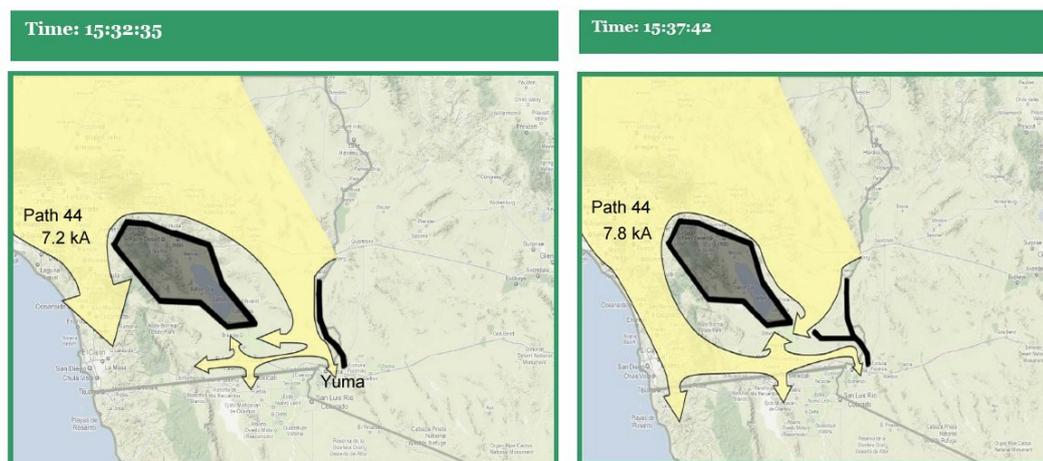
At IID's Coachella Valley (CV) the load of two 230/92 kV transformers increased from 83% to 130% of their nominal rating due to parallel flows in 500 kV, 161 kV and 92 kV grids. At 15:28:16 both transformers tripped for overload. The tripping open-ended the 230 kV line CV-Ramon.

The loss of the CV banks caused a severe voltage depression on the WALC 161 kV system south of Blythe.

Four minutes after the loss of the CV banks the Ramon 230/92 kV transformer tripped for overload and within seconds IID experienced 444 MW under-voltage load shedding. IID also began losing generators and transmission lines. During this phase the current on path 44 peaked at 7.8 kA, but stabilised at 7.2 kA.
