PRELIMINARY REPORT – BLACK SYSTEM EVENT IN SOUTH AUSTRALIA ON 28 SEPTEMBER 2016

A PRELIMINARY OPERATING INCIDENT REPORT FOR THE
NATIONAL ELECTRICITY MARKET – INFORMATION AS AT
9.00 AM, MONDAY 3 OCTOBER 2016

Published: 5 October 2016

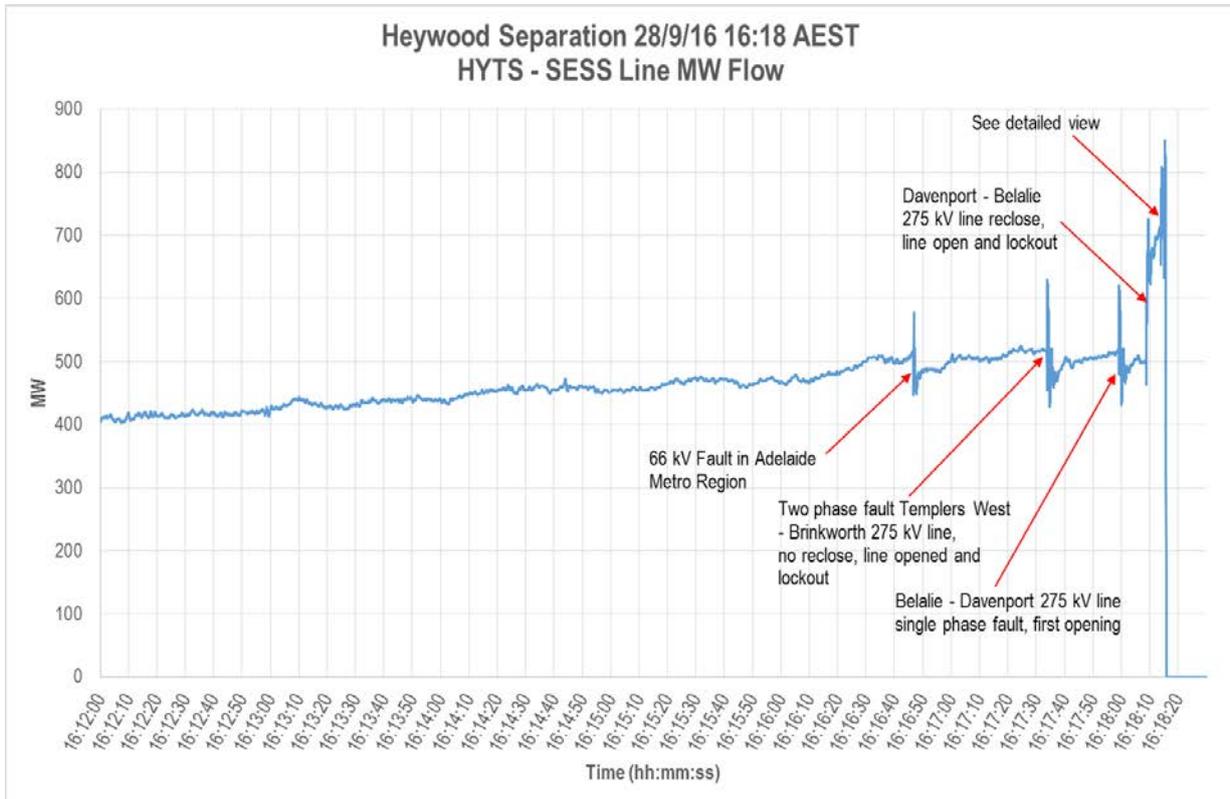
Figure 2 Heywood separation pre-event and event

The reduction in generation during the event, combined with oscillations caused by faults on the transmission network, caused the flow on the Heywood interconnector⁵ to increase to approximately 850 – 900 MW by 16:18:15. Flows between 850 – 900 MW are in excess of the design limits of the interconnector.

Protection settings are in place to avoid damage to network and generation infrastructure in the event of system faults. These settings mean that equipment will open automatically to avoid system damage. At 16:18:15.8, in response to the high power flows on the Heywood interconnector, the protection at South East substation operated to open the Heywood interconnector.

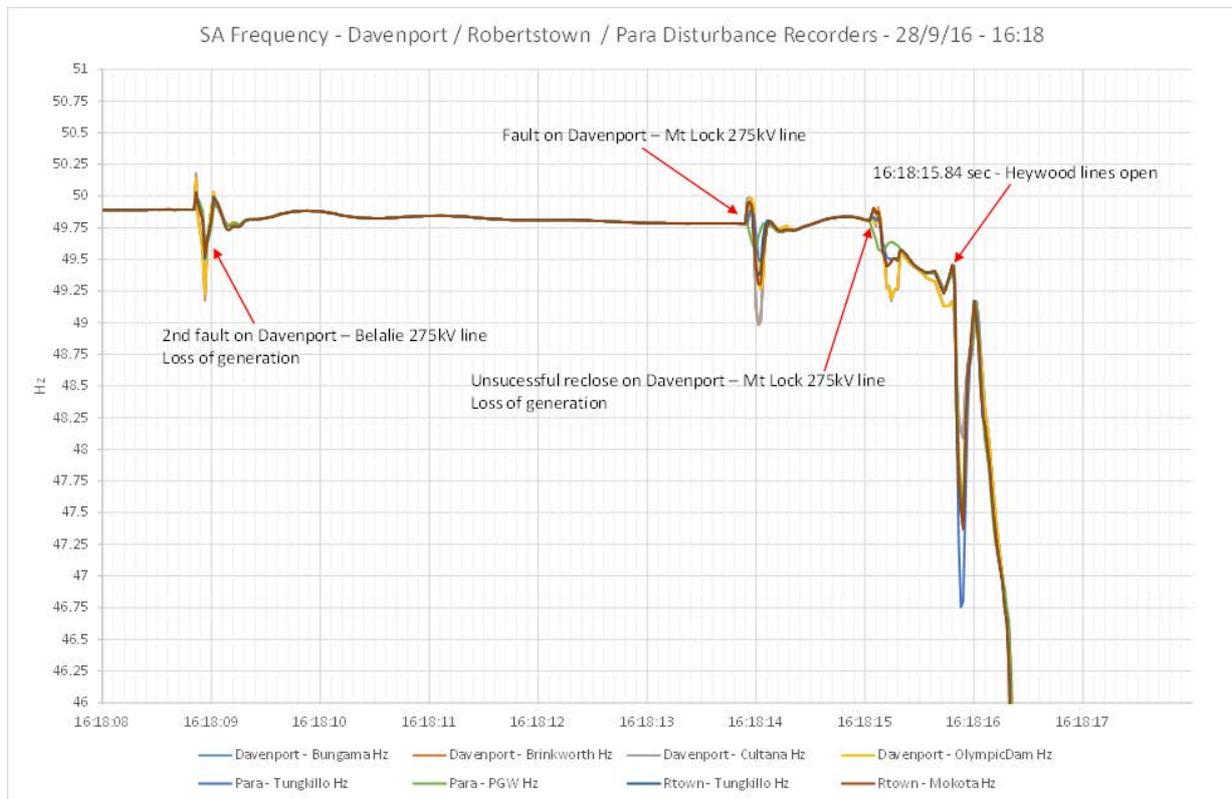
Figure 4 SA frequency during the event

In this event, the 850–900 MW disturbance resulted in a RoCoF that was greater than all design limits of equipment on the system and above the design limits of the UFLS scheme.

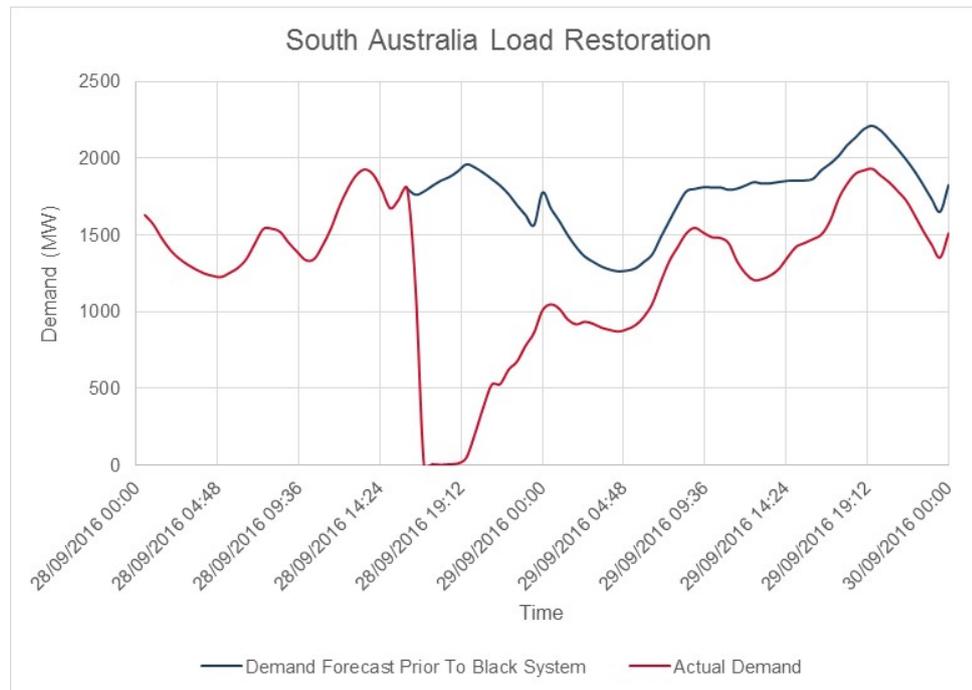
Figure 6 Comparison of forecast and actual load

The figure below illustrates the restoration of consumer load following the SA region Black System as a comparison between the forecast load for SA and the load actually supplied.

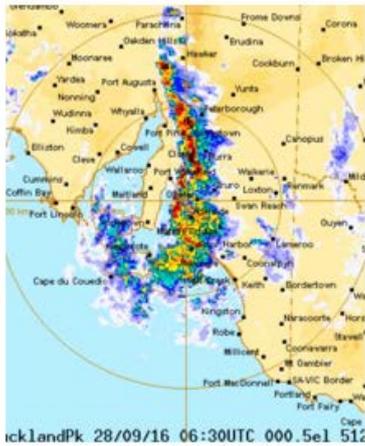
South Australia
rain radar 12 minutes after system black

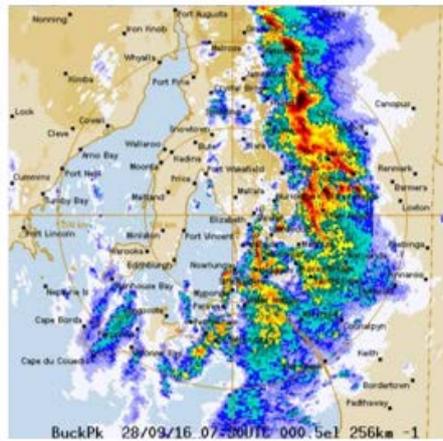
South Australia
rain radar 72 minutes after system black
