Lessons Learned after British Power Disruptions

Why improbable combinations of events do happen

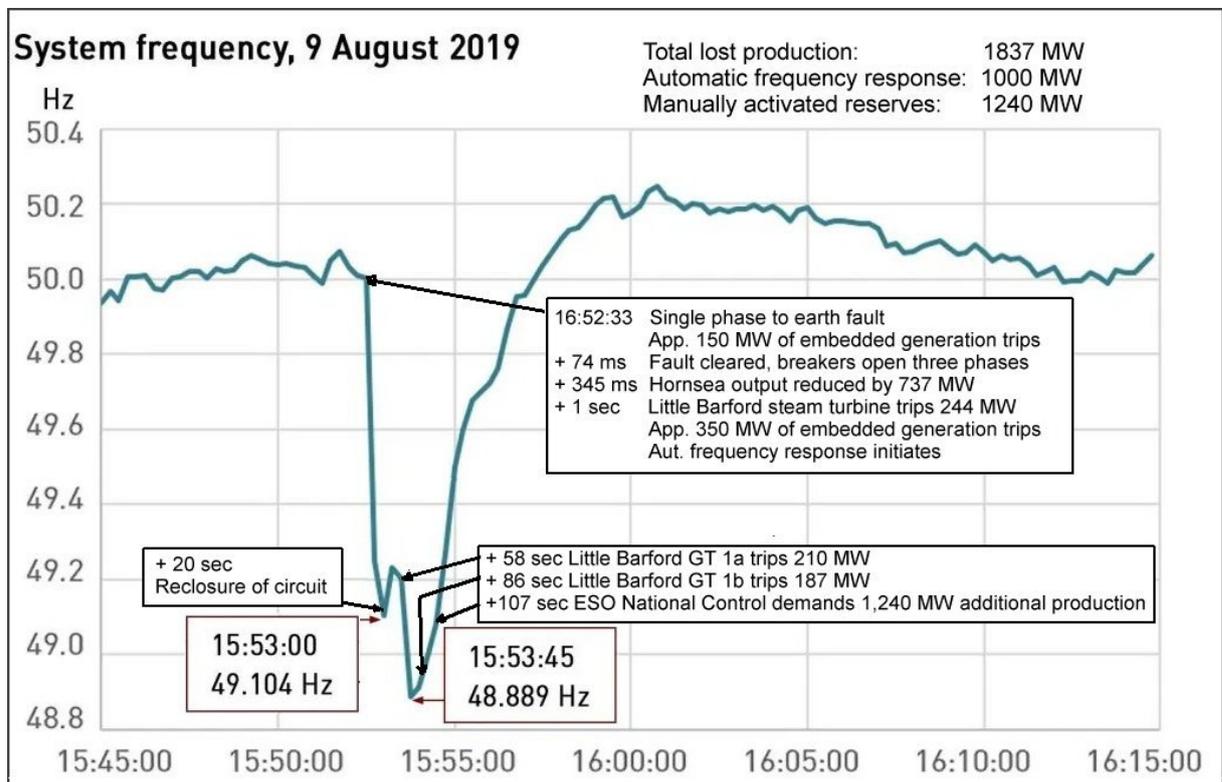
Fig. 1 - Frequency diagram with selected events

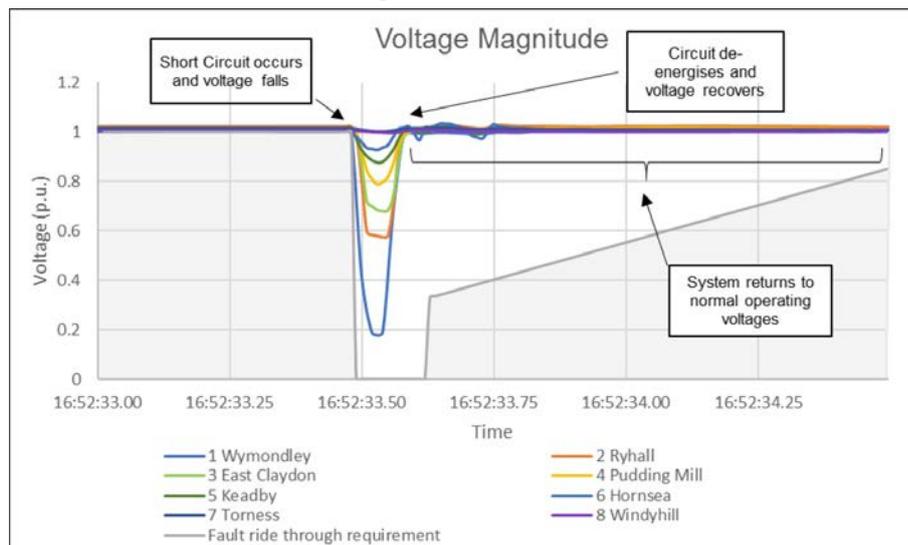
Fig. 2 - Single phase voltage profile at various locations

Fig. 2 shows voltages on the “blue” phase at the time of fault on the Eaton Socon-Wymondley overhead line. The Little Barford power station is connected between the Wymondley (1) and Ryhall (2) substations. The connection point of the Hornsea offshore windfarm is number 6, where the voltage dip was less than 10%.

All recorded voltage dips are well within the fault-ride-through (FRT) requirements (see the profile in fig. 2). Therefore, the voltage dips during the fault cannot justify tripping of any production unit.
