Blackout in South Australia on 28 September 2016

Preliminary overview of events and consequences

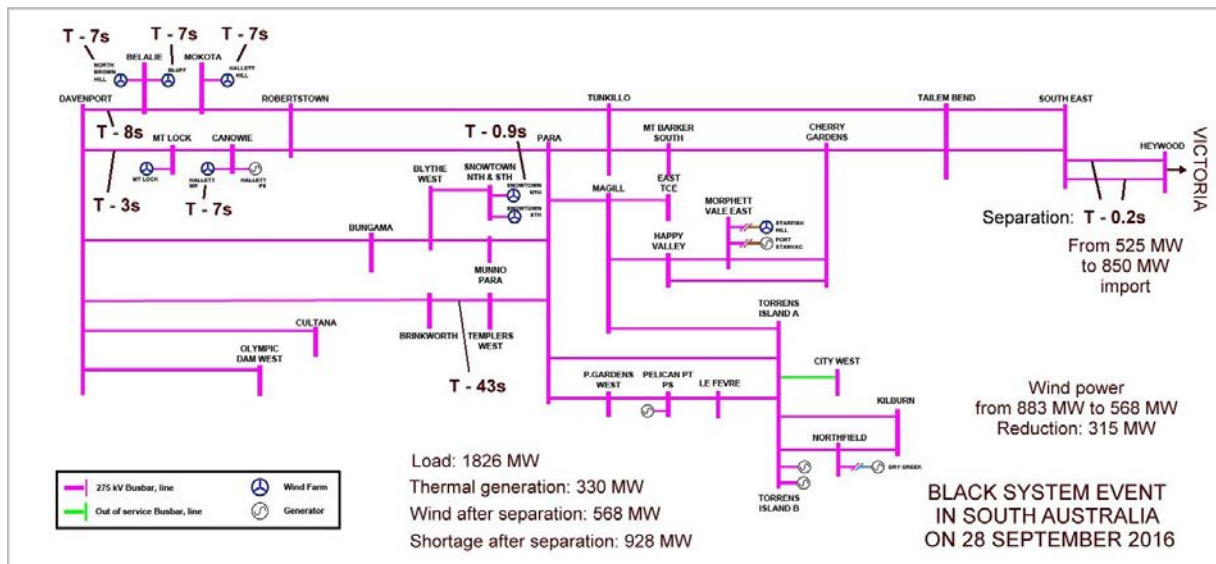
Fig. 4 - SA 275 kV grid

The weather resulted in multiple transmission system faults. In the short time between 16:16 and 16:18, system faults included the loss of three major 275 kV transmission lines north of Adelaide (T is the time of system collapse):

- Brinkworth – Templers West (T – 43s)
- Davenport – Belalie (T – 8s)
- Davenport – Mt Lock (T – 3s)

At T – 7s the output from four wind farms fell from 199 MW to 76 MW. Six seconds later the output from two other wind farms (Snowtown North and South) fell from 188 MW to -4 MW. The total loss of production was 315 MW.

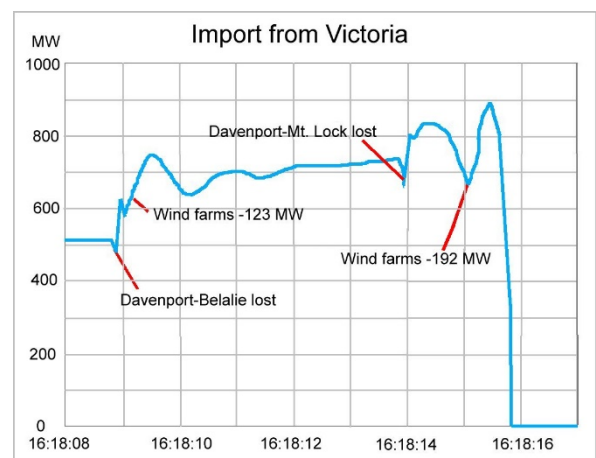
Fig. 3 - Exchange with Victoria

The lost production caused a corresponding increase of import from Victoria to above the overload limits. Both circuits tripped and left the SA power system with more than 900 MW shortage.

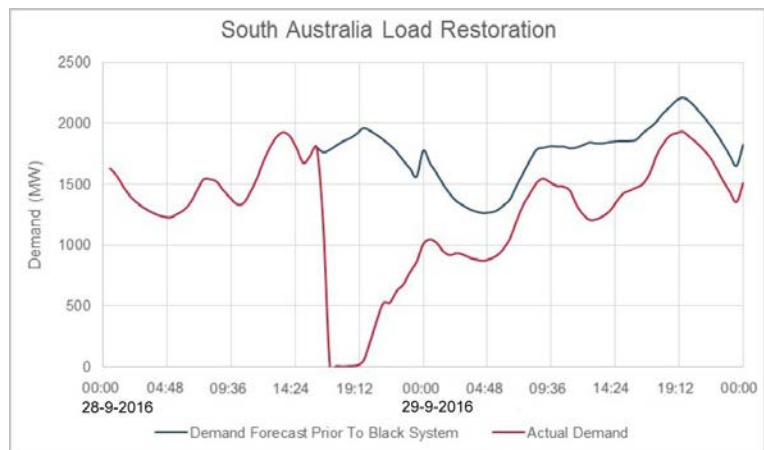
Fig. 5 - Resumption of supply started about 3 hours after the blackout.
