PRELIMINARY REPORT – BLACK SYSTEM EVENT IN SOUTH AUSTRALIA ON 28 SEPTEMBER 2016

A PRELIMINARY OPERATING INCIDENT REPORT FOR THE
NATIONAL ELECTRICITY MARKET – INFORMATION AS AT
9.00 AM, MONDAY 3 OCTOBER 2016

Published: 5 October 2016

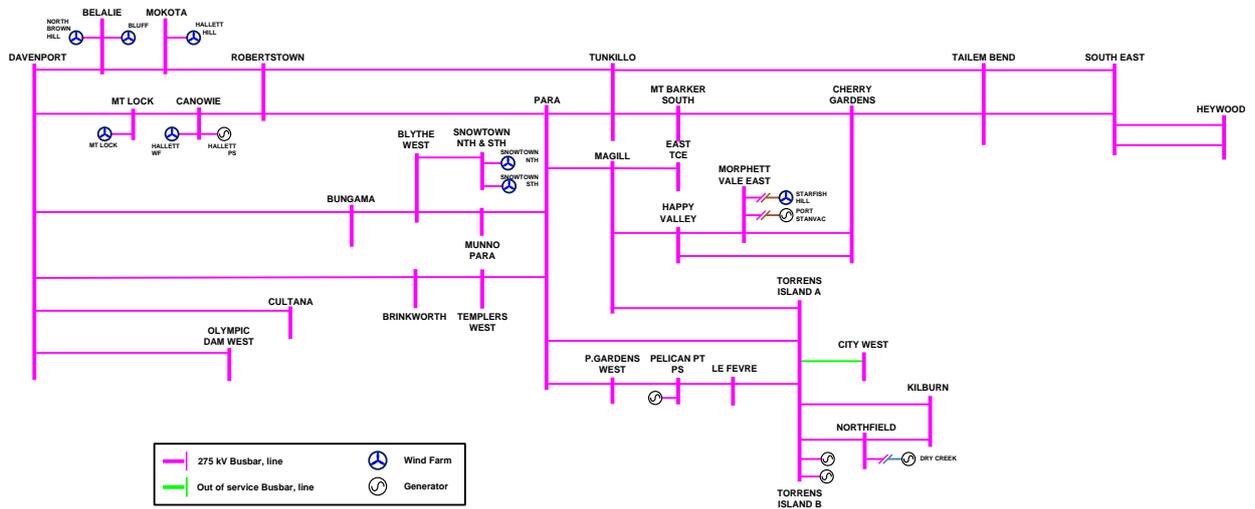
APPENDIX A. POWER SYSTEM DIAGRAM

Diagram illustrating the status of the South Australian 275 kV transmission network before the event - for clarity lower voltage networks such as 132 kV are not illustrated
