## The Useful Blackouts

The undisturbed supply of electricity depends on efficient operational strategies. The strategies should be updated concurrently with power system development. The current transition of many power systems into renewable and non-dispatchable production could be a reason for reconsidering and updating system security strategies.

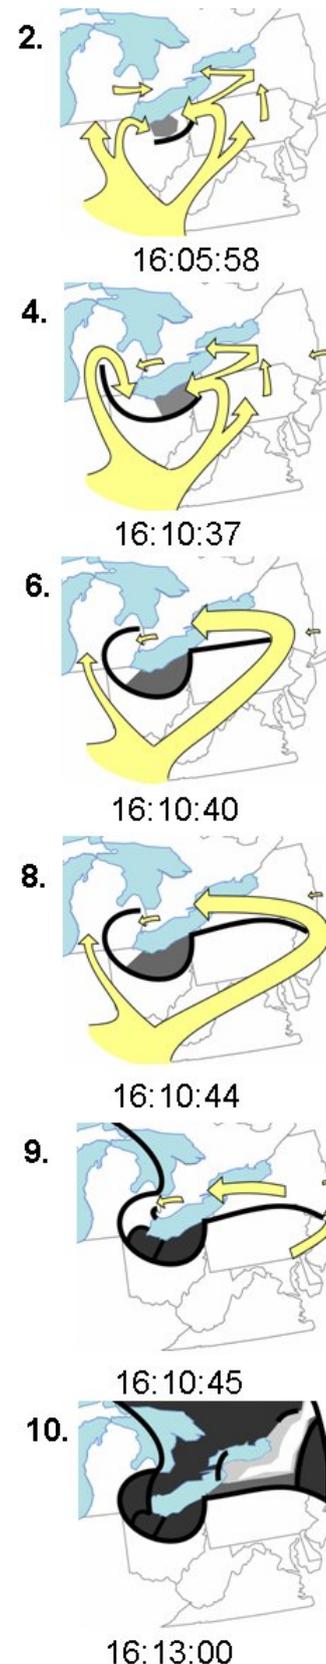
Grid operators are supposed to have very robust monitoring equipment and a very good overview of their grids. It is obvious from the telephone transcripts that MISO had to rely on the TV stations for information on the power system condition.

<p>F0622duaneSV2 105 Original Transcription Edited by Counsel Times Noted in Transcription are 7 minutes ahead of MISO Network System Time</p> <p>1 2003 08-14 CH25 OSP ENG 1533hrs.WAV</p> <p>2 MISO/Jason Marshall: Okay. Well, we'll</p> <p>3 -- I'm going to start calling control areas and telling</p> <p>4 them to make sure they have generation running. We've</p> <p>5 got blackouts all over the place. There's power --</p> <p>6 <u>you're watching the TV? We've got lines tripping</u></p> <p>7 <u>everywhere.</u></p> <p>21 MISO/Jason Marshall: That works for me.</p> <p>22 <u>I don't know if you've been watching the</u></p> <p>23 <u>TV, but we have been experiencing a ton of line trips.</u></p> <p>17 MISO/Ron Mihbachler: <u>I don't know if you</u></p> <p>18 <u>have been watching, if you have been staying up or not,</u></p>	<p>19 <u>but I guess New York City or New York is out,</u></p> <p>20 <u>Cleveland, and I think Detroit.</u></p> <p>21 MISO/Keith Mitchell: Okay. <u>Toronto, too.</u></p> <p>22 MISO/Ron Mihbachler: Yes, I think Toronto</p> <p>23 is out as well.</p>

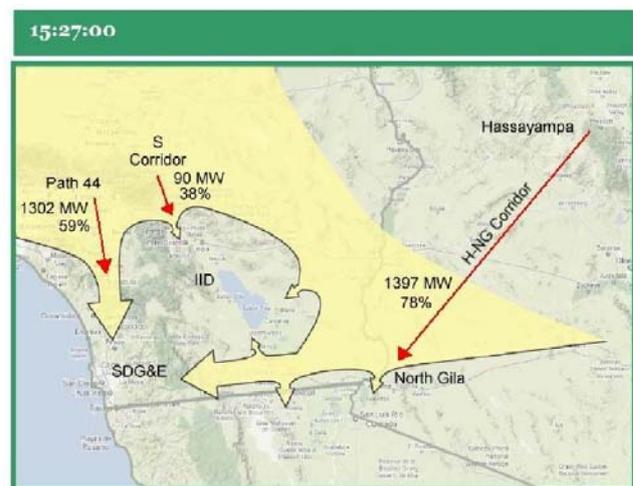
The initiating event was a routine switching to isolate a capacitor bank at North Gila in Arizona. The switching was carefully planned. The technician had completed step 6, but was distracted by other communication and wrote the time on the line for step 8 in his check list. Therefore he skipped two steps and continued with step 9. The result was an arc over the switch and the automatic disconnection of the 500 kV line Hassayampa-North Gila (H-NG).

After the disconnection of H-NG the flows were redistributed. Flow on path 44 increased by 84% to 2,362 MW or 5.9 kA. At 8.0 kA the SONGS<sup>6</sup> separation scheme would be initiated.

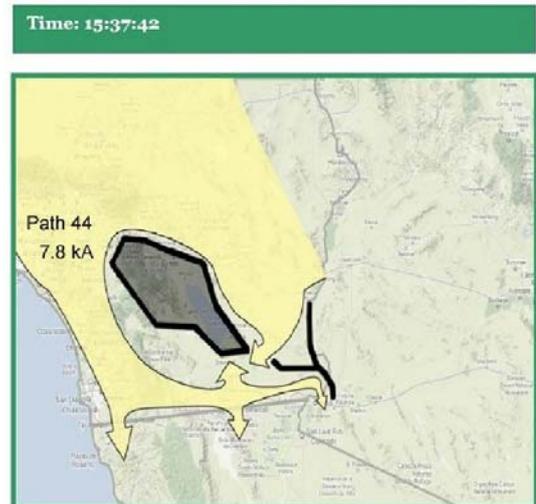
Several other lines and generators tripped and at 8.0 kA the SONGS separation scheme operated (11 minutes after H-NG tripped). The operation effectively separated SDG&E from the rest of the Western Interconnection. It created an island consisting of the SDG&E system, the remaining Yuma-area load, and CFE's California Control Area.

The SDG&E/CFE/Yuma island had a significant imbalance between generation and load. The activation of the Under Frequency Load Shedding (UFLS) programs was not able to prevent the island from collapsing.
